The Rehabilitation of the Asbestos Mine Area, Cyprus

Eur Ing Kyriacos Kyrou

Executive Engineer, Water Development Department, Cyprus

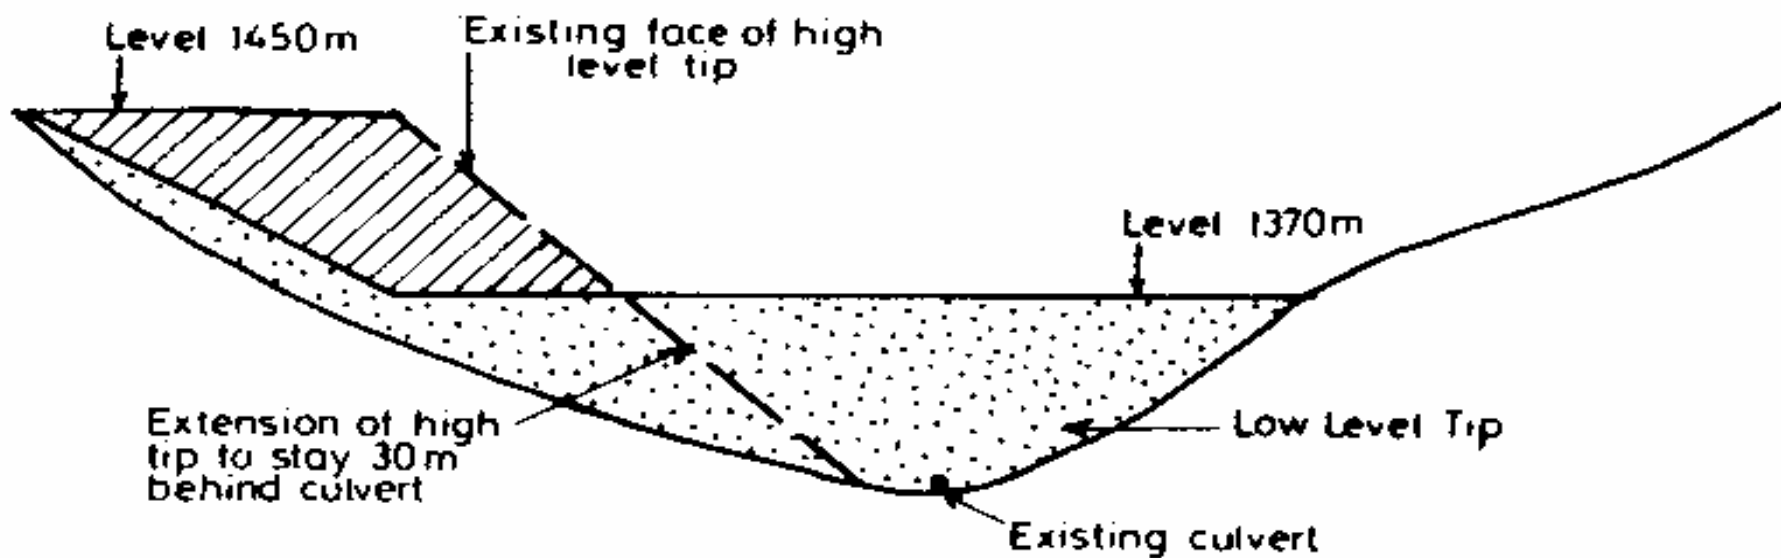
Fig.3 Typical Cross Section across Loumata Valey Tip.

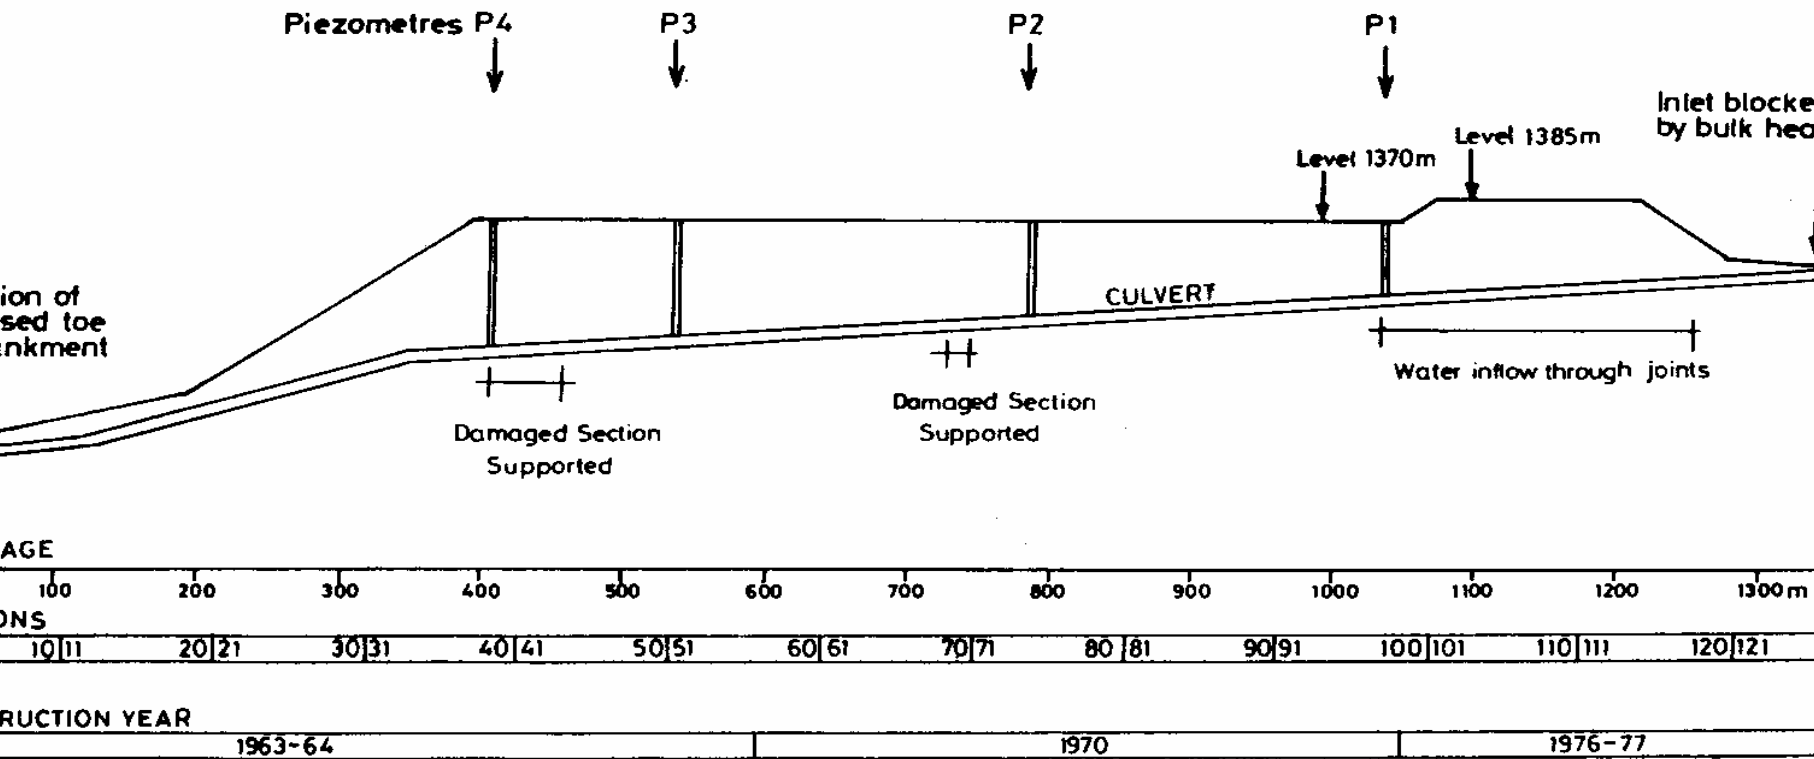
2 Longitudinal Section along culvert and existing Loumata Valley Tip

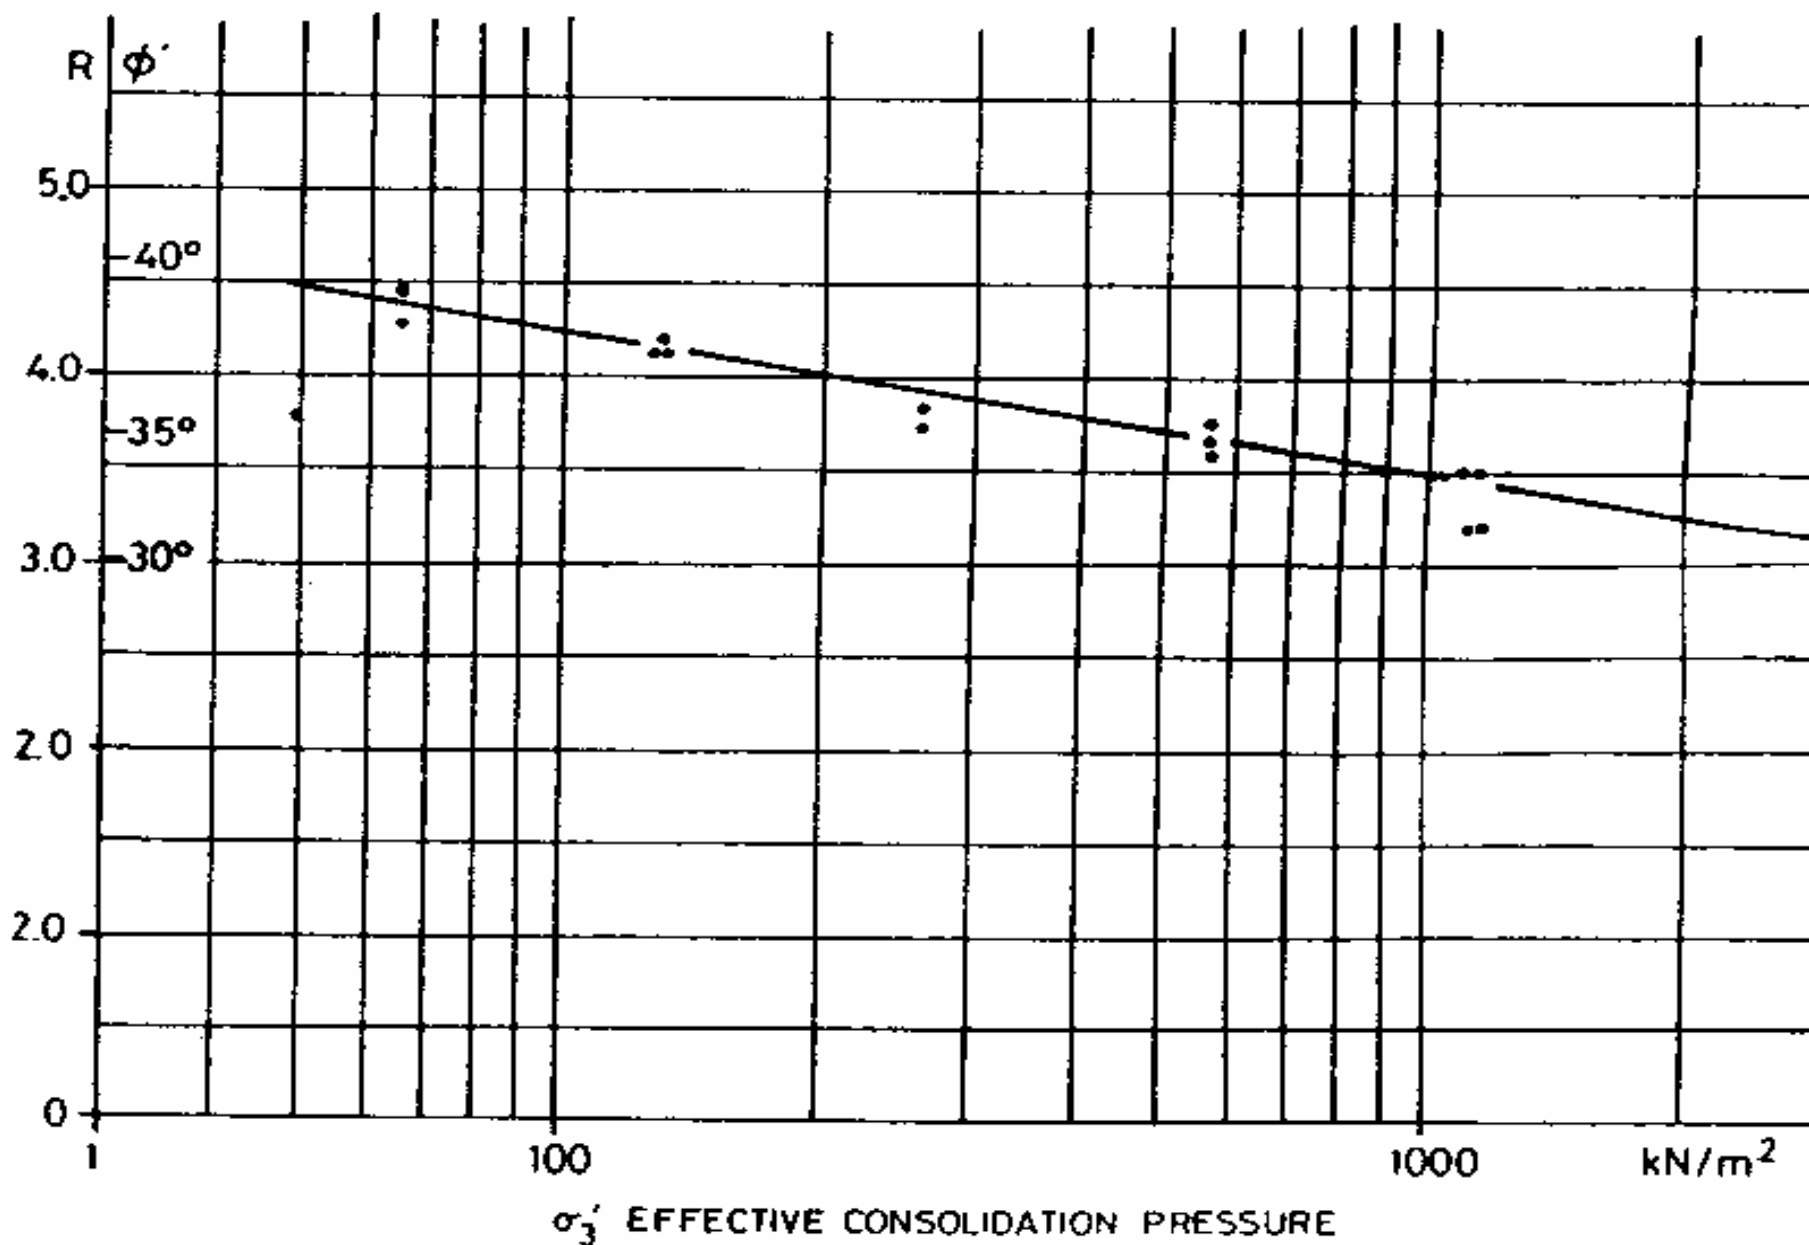
Variation of stress R and angle of shearing resistance ϕ' with consolidation pressure

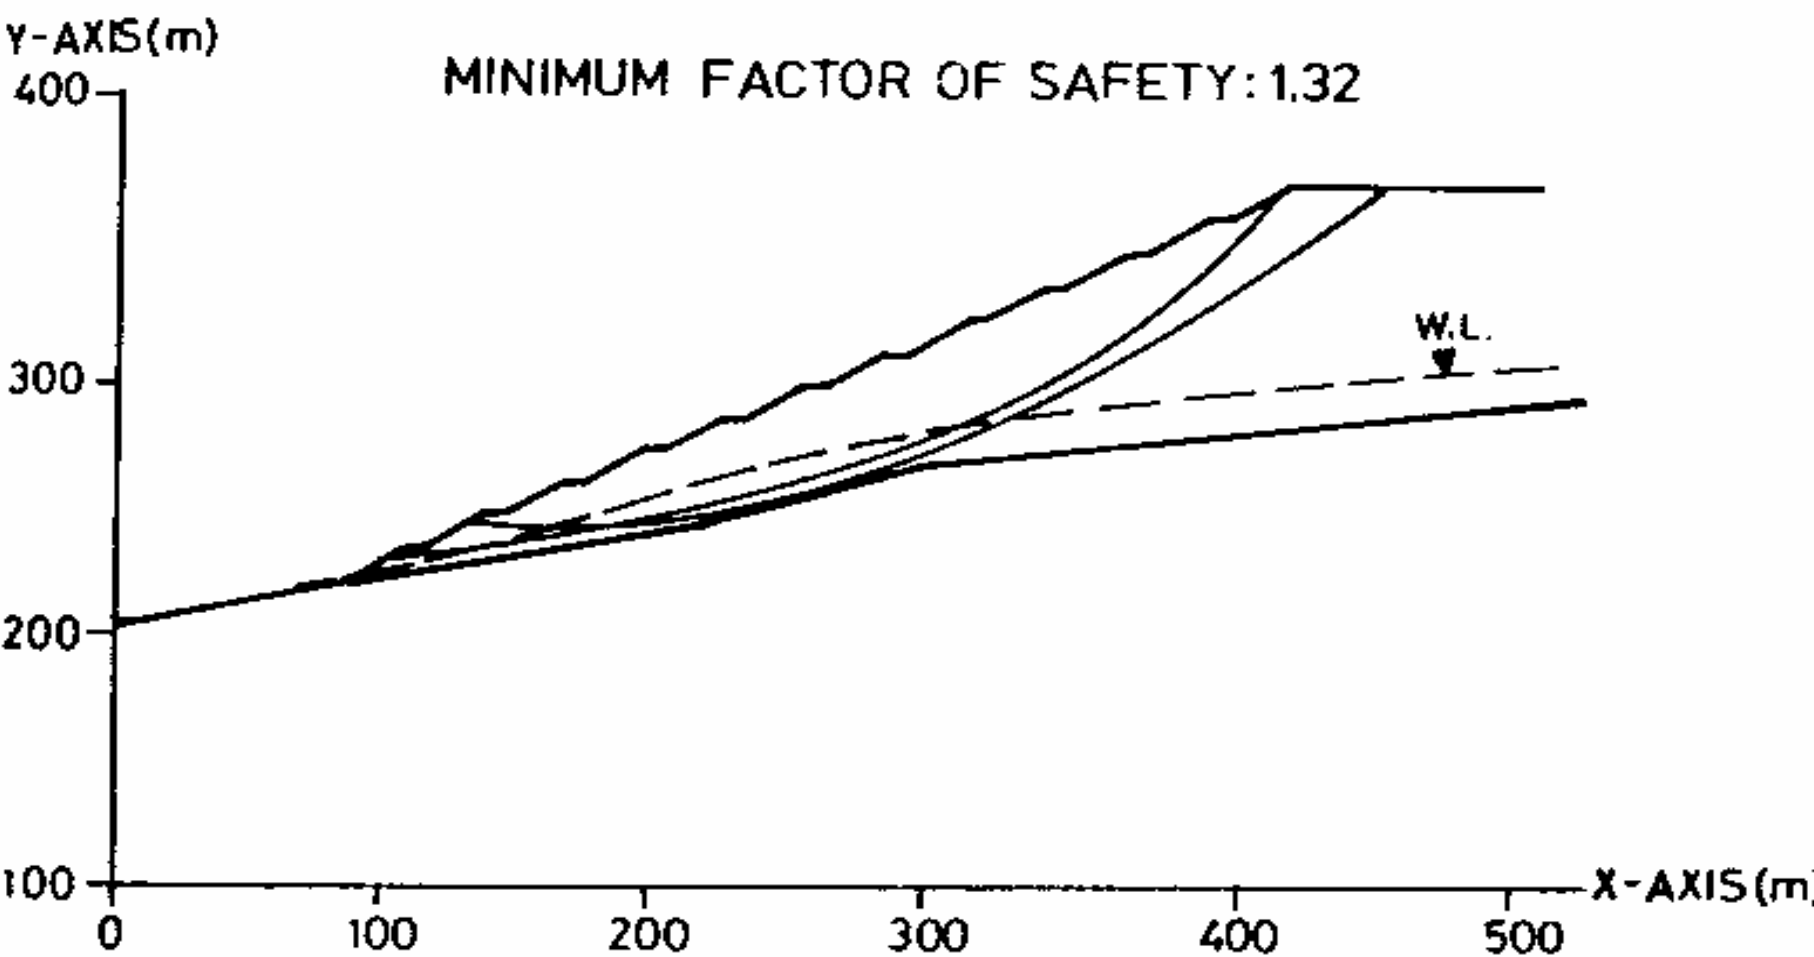
Fig. 6 Loumata Tip Static Analysis

- static loading
- earthquake loading, pseudostatic stability analyses
- Calculation of displacements(Newmark, 1965)

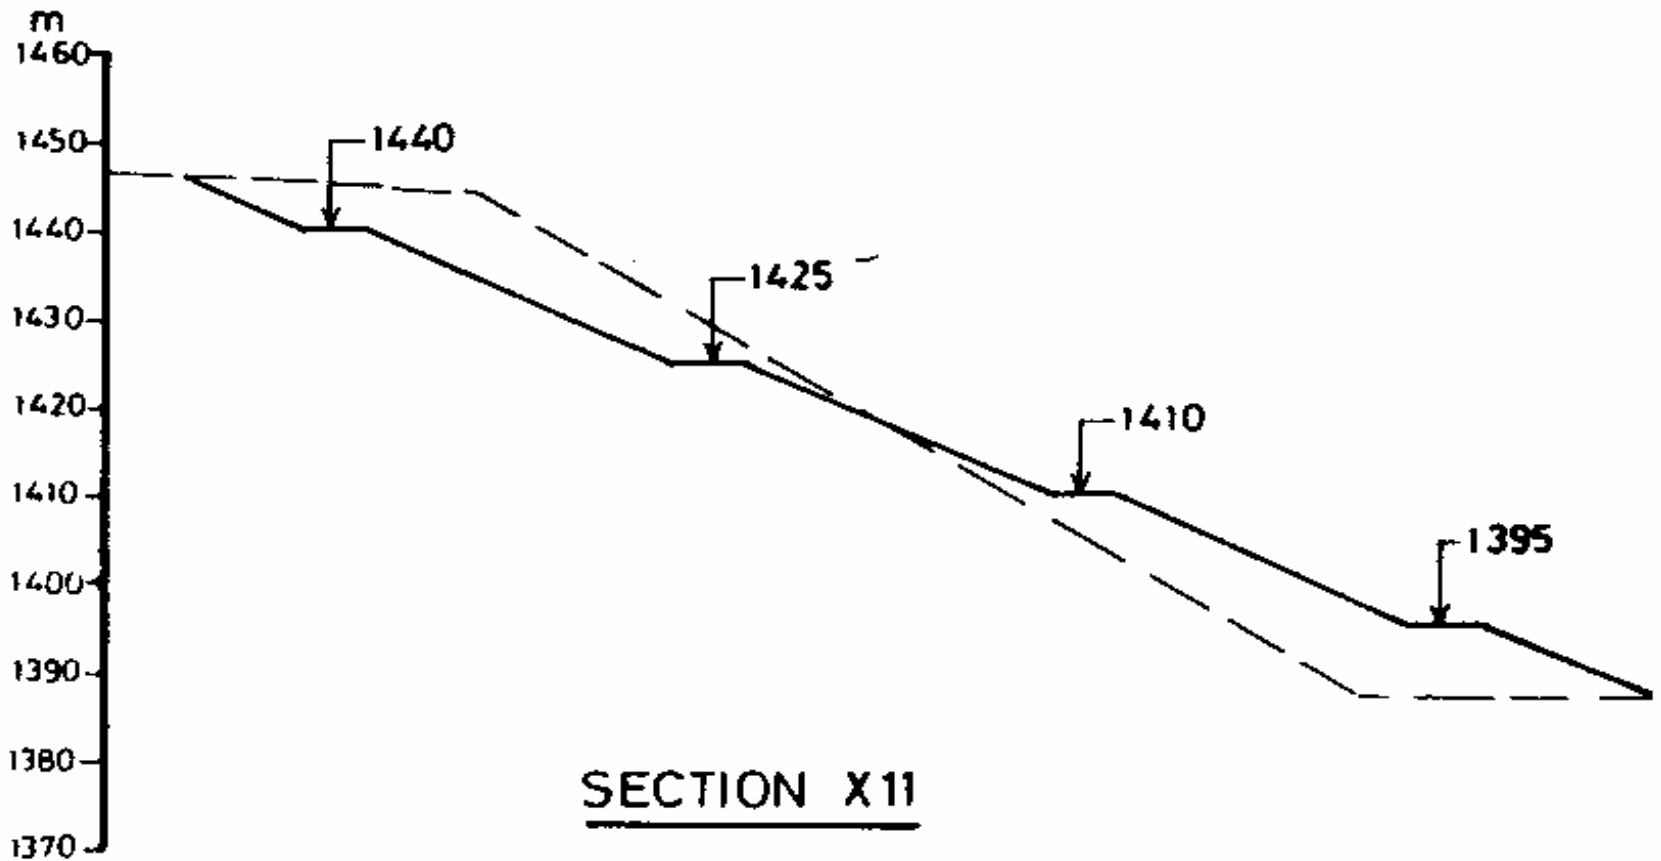
Fig.4 Typical Section adopted in the 1996 Reprofiting Contract

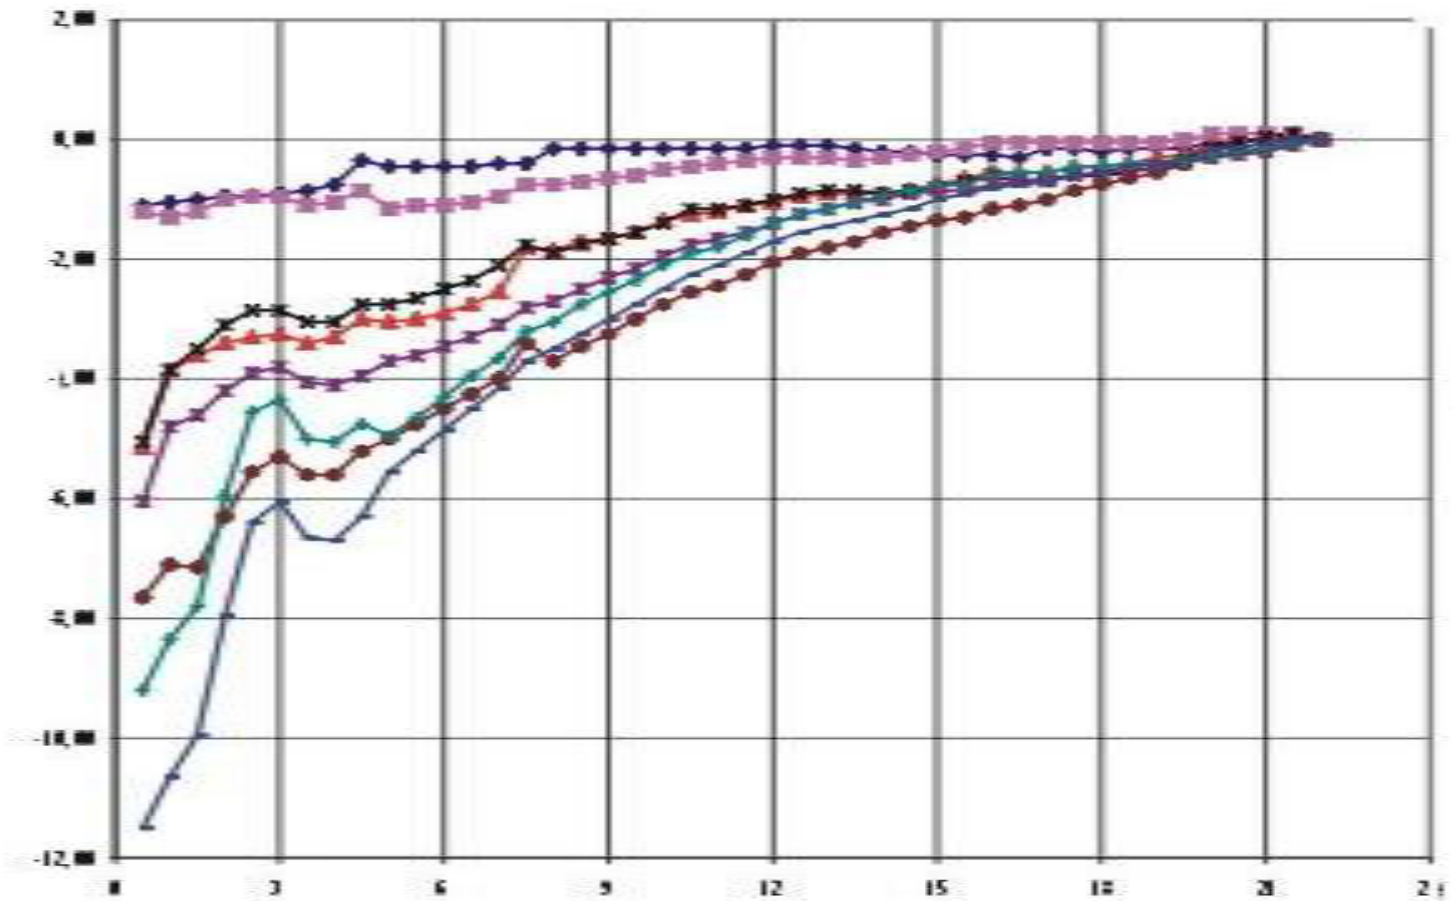
AMANTO 5 MNE
OLDWA 5TE TIP5 - INCLINOMETER HOLE 11-ABPLANE

- **for safety reasons and better understanding of the mechanical behaviour of the waste material**
- **measurement of surface and deep seated ground movements and water levels**
- **movements recorded to date indicate that the old tips are prone to small creep type movements .**

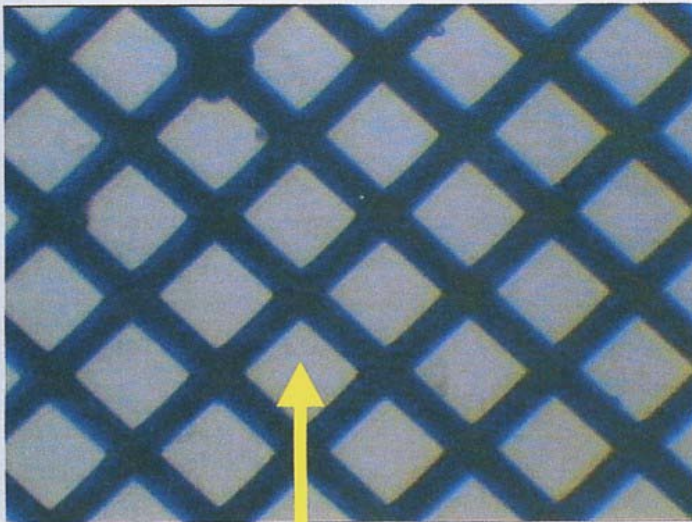
Grid

0,0094 mm²

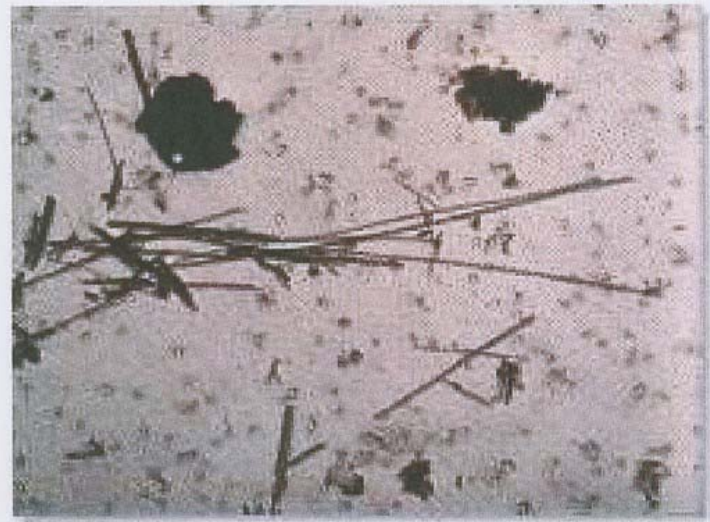
TEM (x 10.000)
